Residential Inspection Report

1234 Front St., Olive Branch, MS 38654

HomeSafe/Advanced Home Inspections

Report: SAMPLE #2

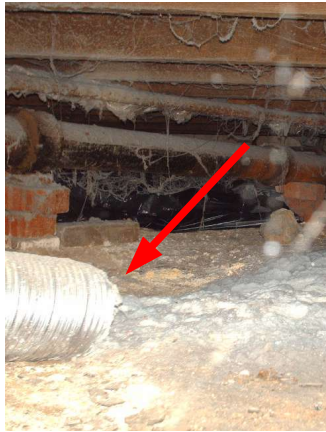
Dryer exhaust vent terminating in the crawl space.

Repair: The clothes dryer vent pipe in the crawl space should be directed to the exterior of the building. Improperly-vented dryer lines introduce humid air (moisture) and may damage the building. Also, a blocked dryer vent line can lead to a fire in the dryer.

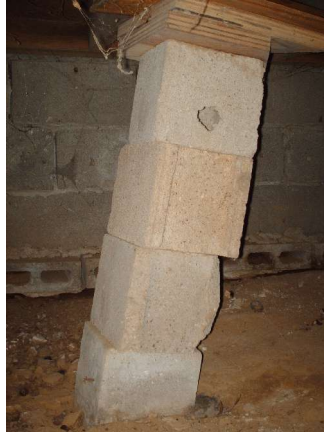
Damaged column in need of repair.

Repair: Columns have shifted and are not supporting the floor structure as intended. It is recommended a foundation contractor evaluate the columns and repair as necessary.

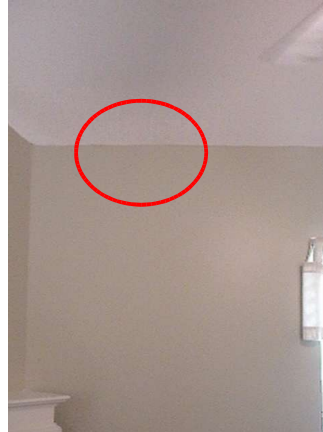
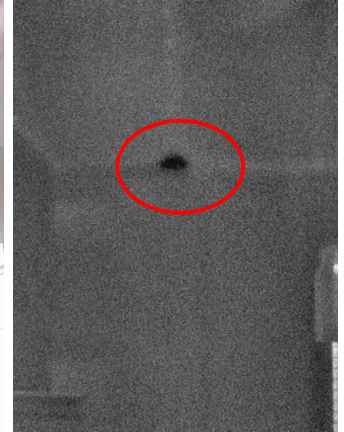
Roof leak in the area of the living room.

Infrared view of the roof leak. Dark area is moisture.

Repair: Roof leak identified in the living room. It is recommended a licensed roofing contractor be consulted and make any repairs necessary.

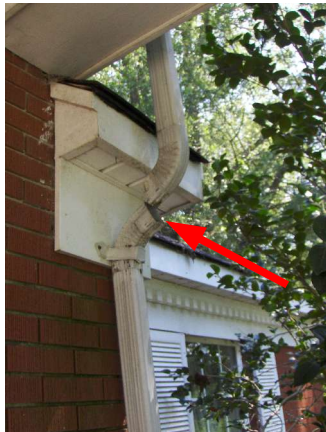
Damaged downspout observed on the northwest corner of the home.

Repair: Damaged downspouts should be repaired. Problem noted on the northwest side of the home.

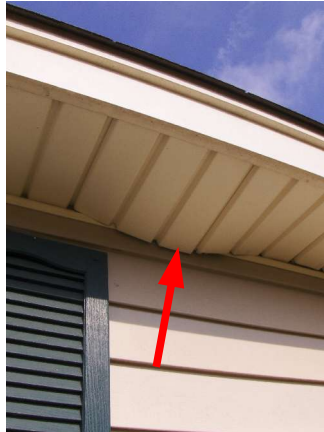
Loose siding on the east side of the home.

Repair: Loose and/or missing fascia and soffit. The wood immediately under the roof (soffit and fascia) are missing or loose thereby exposing the roof rafters to the elements and allowing vermin entry. Problem noted on east side of home.

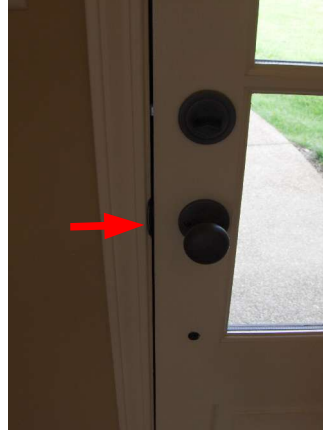
Mis aligned door latch and striker plate on the front door.

Repair: Door latch and striker plate appears to be mis aligned. Problem noted on front door.

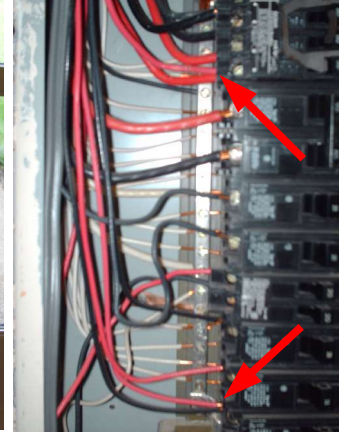
Double tapped circuits on the main panel.

Repair: Two or more branch circuits attached to one circuit breaker or fuse. These "double taps" should be separated so that each circuit is served by a separate over current protector.

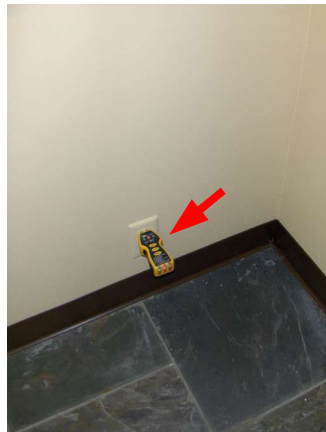
Hot and neutral wire reversed on outlet in the laundry room.

Repair: Hot and neutral wired backwards outlet(s) observed. The outlet(s) are polarity reversed and the circuit(s) should be investigated and repaired as necessary. Problem noted in laundry room.

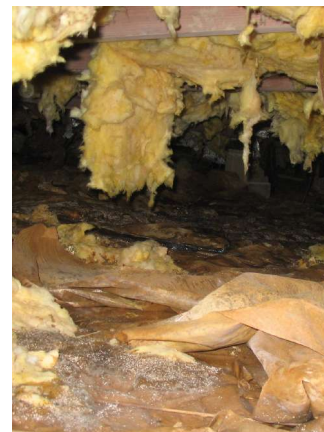
Insulation in the crawl space is falling and in need of repair.

Repair: Loose, damaged, or missing sections of floor insulation above the crawl space should be repaired.

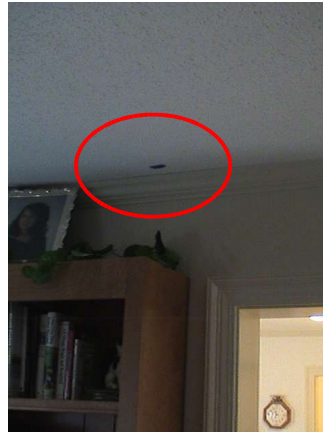
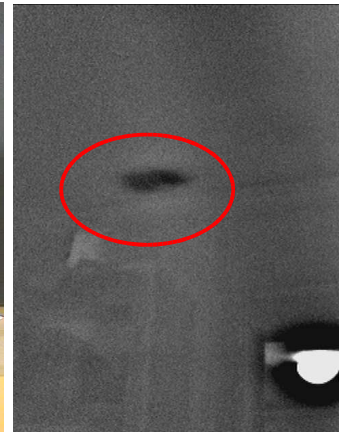
Waste line leak on the living room ceiling.

Infrared view of the leak. Dark are is moisture.

Repair: Waste line observed leaking. Problem observed above the living room ceiling.

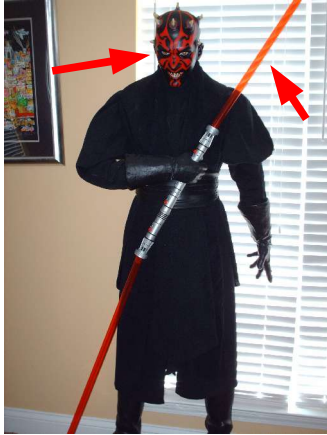
Sith lords and light sabers are dangerous.

Repair: Sith lord Darth Maul should be removed from in front of the window.

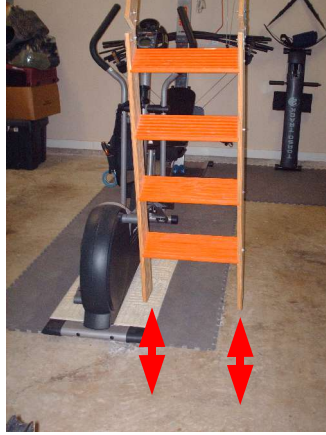
Folding attic stairs to short for the ceiling height.

Repair: Folding attic stairs not not designed for the ceiling height it has been built into.
